Treasure Valley Home Inspectors, LLC
208-488-3218
treasurevalleyhomeinspectors.com

Home Inspection Report
11853 W Pinewood River Ln
Star, ID 83669

Inspected By: Samuel Kimball

Prepared For: Vicki Lynn
Inspected On Fri, May 26, 2023 at 12:00 PM

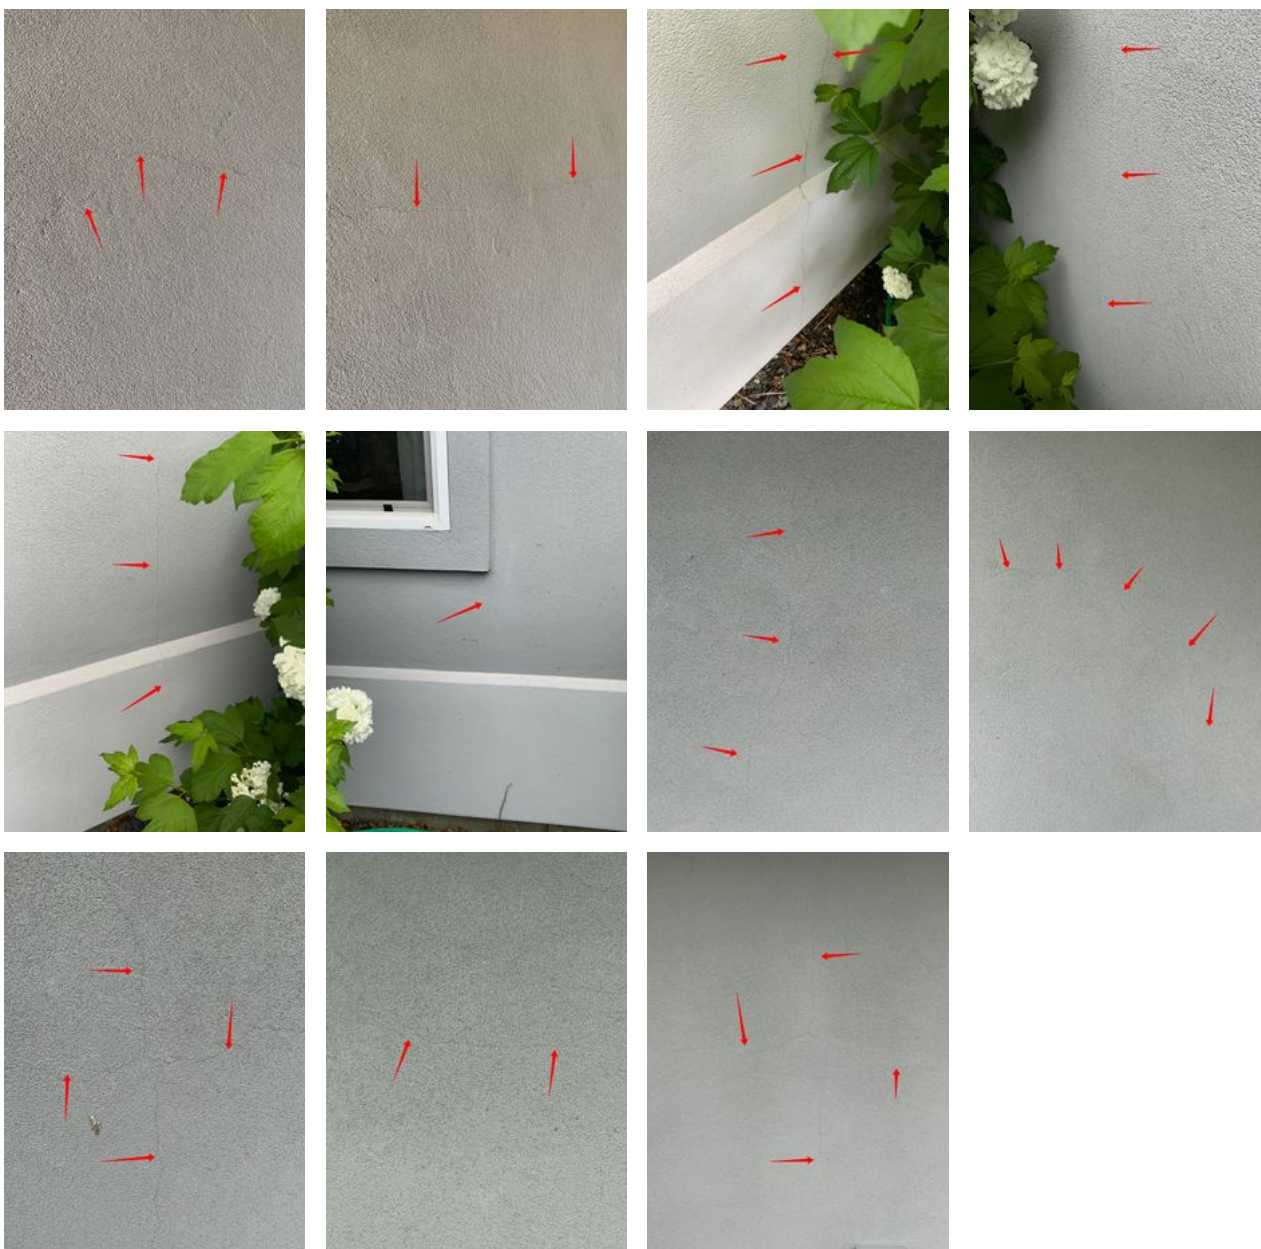
Exterior: Exterior Covering

Fractures present at various locations on the stucco exterior. These will periodically need re-sealed and are considered to be routine maintenance with stucco exterior homes.

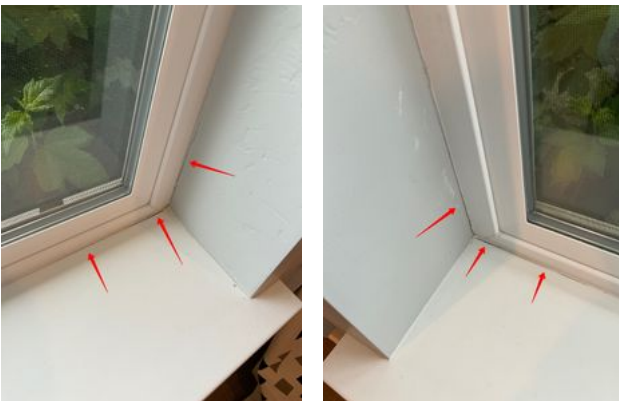
Interior: Window Types

Recommend touch up caulk on interior window sills as needed to improve moisture barrier.

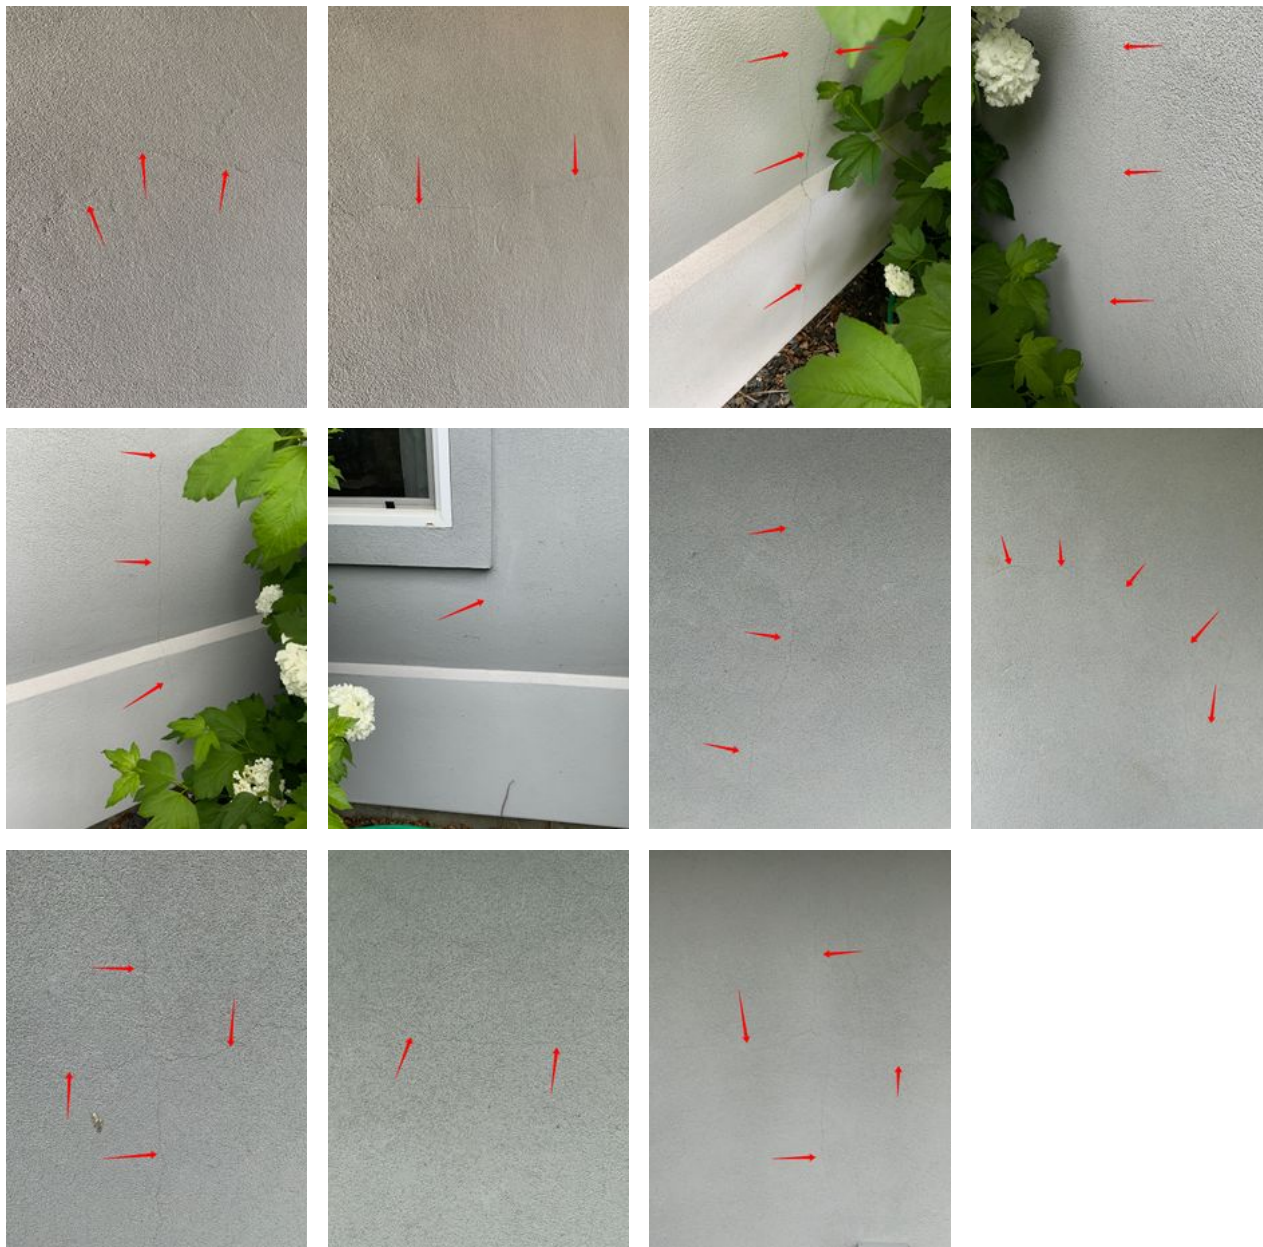
Comment 2
Deficiency

Fractures present at various locations on the stucco exterior. These will periodically need re-sealed and are considered to be routine maintenance with stucco exterior homes.

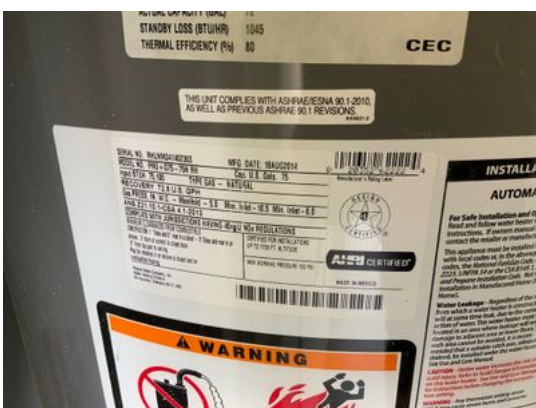
Comment 10
Deficiency

The expansion tank appears to have failed. Recommend further evaluation and repair.

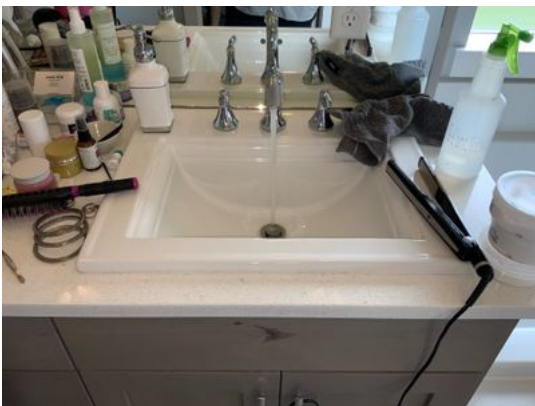
Comment 13

The right side sink mechanical drain stop does not stay engaged.

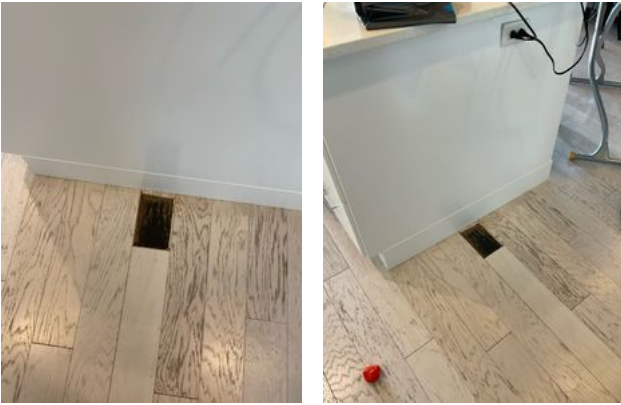
Comment 14
Information

Portions of the floor near the kitchen island were in the process of being repaired.

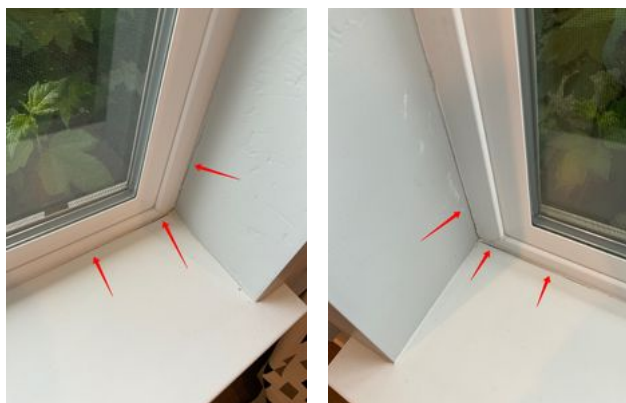
Comment 15

Recommend touch up caulk on interior window sills as needed to improve moisture barrier.
