Treasure Valley Home Inspectors, LLC

## Home Inspection Report

1887 N Buena Vista Ave  
Meridian, ID 83646

Inspected On Mon, Dec 29, 2025 at 9:00 AM

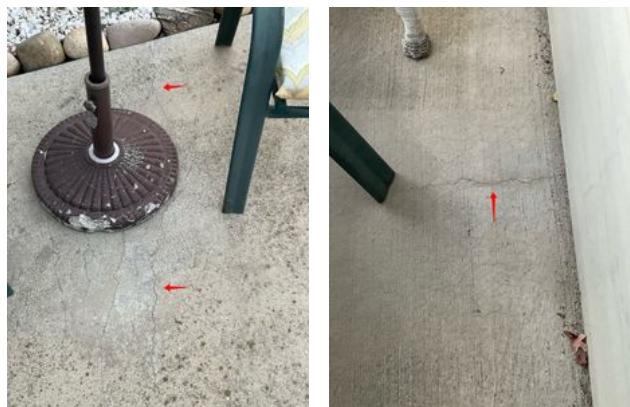
Fractures present on the concrete patio slab.

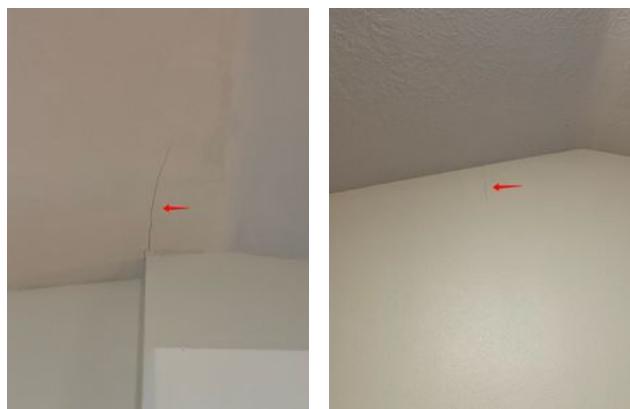
Fractures present in the ceiling drywall. Portions of this fracture are at a tape joint while portions of the fracture indicates that a portion of the sheet of drywall has broken . This could be from someone walking in the attic or is a sign of past structural settlement. No further signs of structural settlement were noted at the time of the inspection i.e. window/door header fractures, floor slopes, significant foundational fractures etc. The ceiling drywall should be repaired and monitored. If the fracture happens again then active settlement may be occurring. Recommend further evaluation and repair.

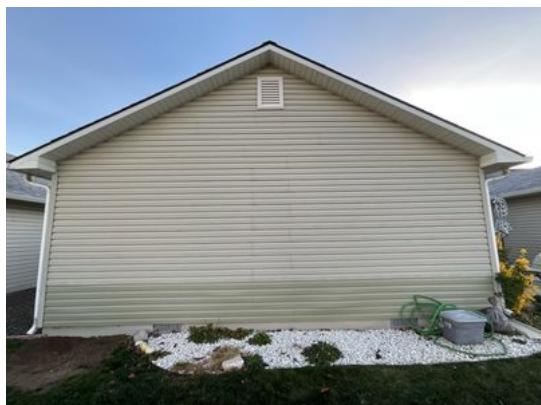
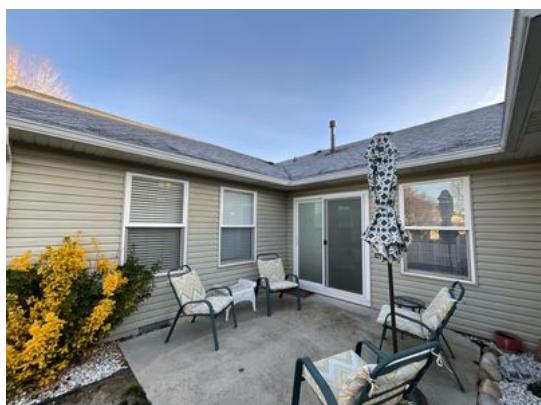
Various portions of the siding are bowed/flared.

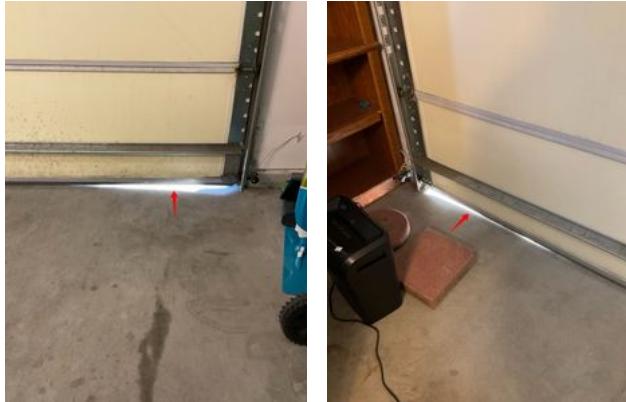
The portions of the garage door do not fully seal against the weather stripping.

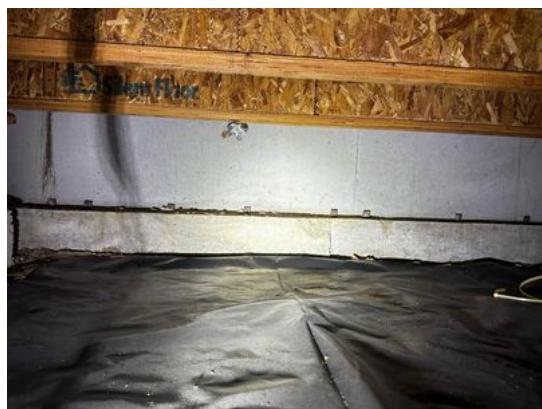
Vertical fractures located in foundation concrete. These are not generally indicators of structural settlement. Sealing these fractures may prevent further expansion of the crack due to moisture intrusion/freezing. Recommend monitoring this fracture and sealing if the fracture width expands to 1/8 of an inch.

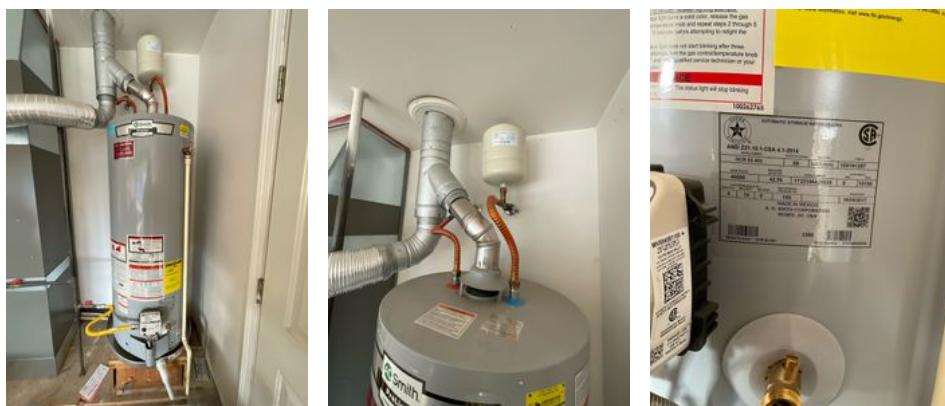
Recommend fire caulking the water heater supply through wall penetrations.

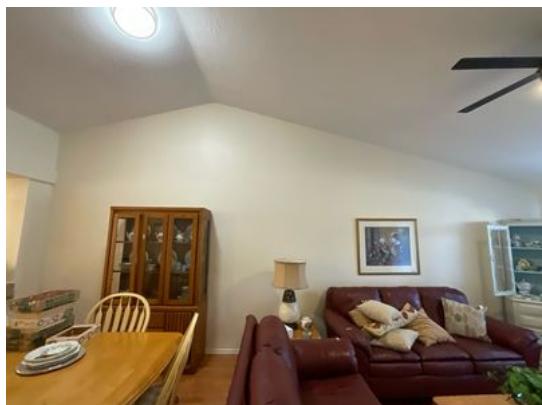
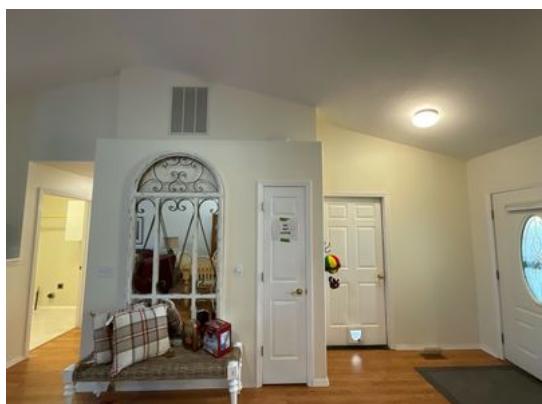
Fractures present in the ceiling drywall. Portions of this fracture are at a tape joint while portions of the fracture indicates that a portion of the sheet of drywall has broken . This could be from someone walking in the attic or is a sign of past

structural settlement. No further signs of structural settlement were noted at the time of the inspection i.e. window/door header fractures, floor slopes, significant foundational fractures etc. The ceiling drywall should be repaired and monitored. If the fracture happens again then active settlement may be occurring. Recommend further evaluation and repair.

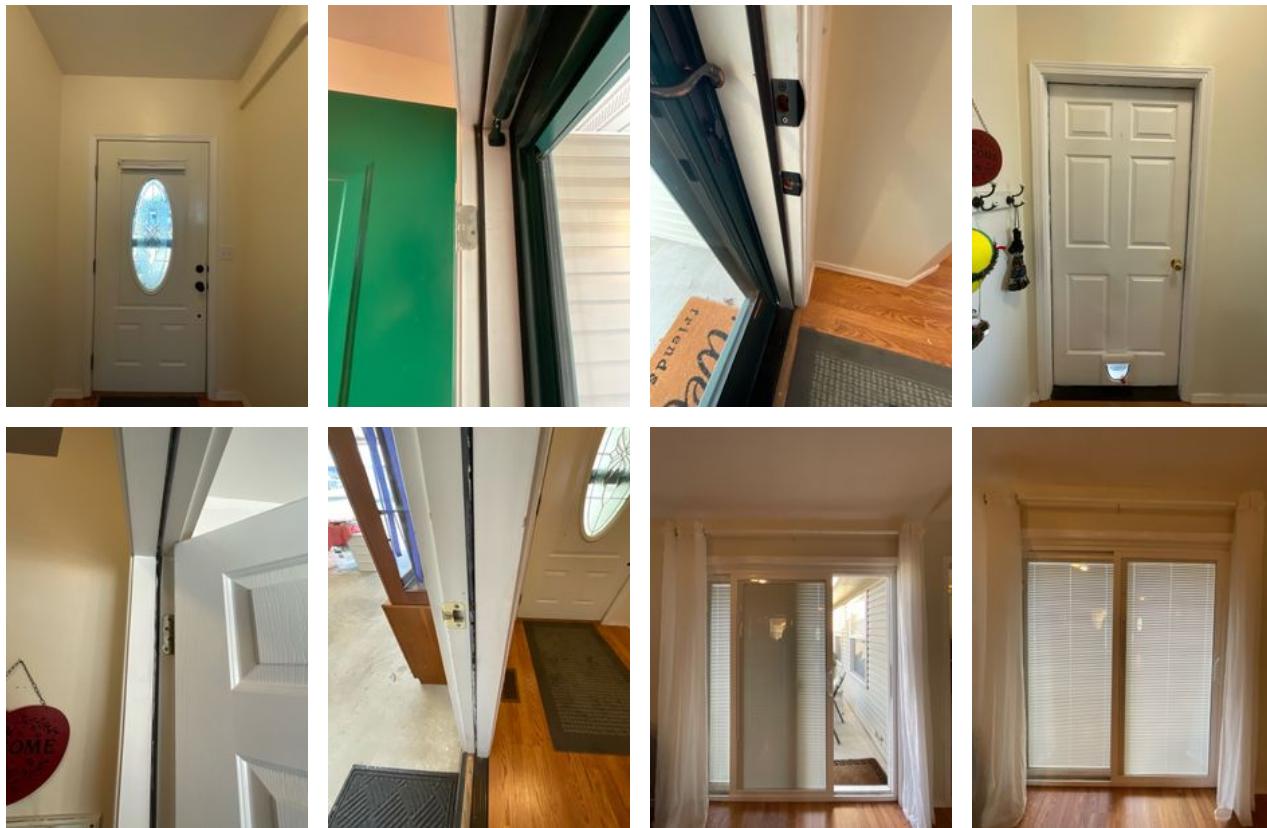
The front entry deadbolt is sticking. Recommend adjusting.

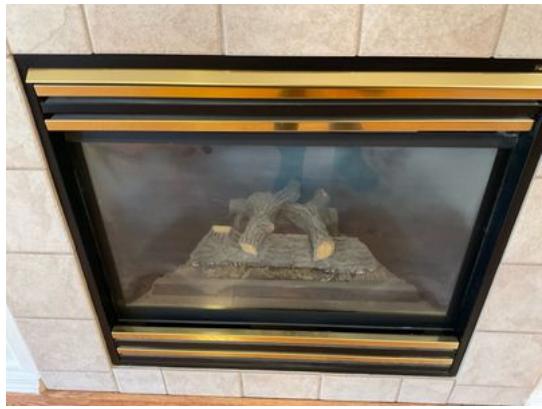
Condition: Further Evaluation Required

The fireplace did not ignite at the time of the inspection. The floor gas valve may be turned off. Recommend further evaluation.
