Treasure Valley Home Inspectors, LLC
208-488-3218
treasurevalleyhomeinspectors.com

Home Inspection Report
11853 W Pinewood River Ln
Star, ID 83669

Inspected By: Samuel Kimball

Prepared For: Vicki Lynn
Inspected On Fri, May 26, 2023 at 12:00 PM

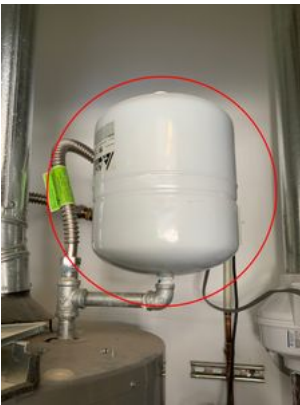
Plumbing: Water Heater: Manufacturer

The expansion tank appears to have failed. Recommend further evaluation and repair.

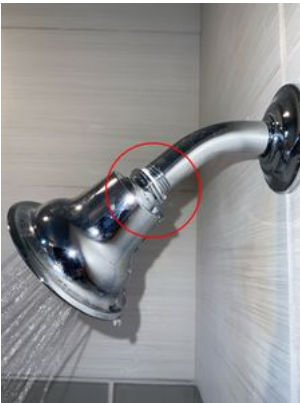
Bathrooms: Bathroom #2: Shower

Shower head is leaking where it attaches to the shower arm.

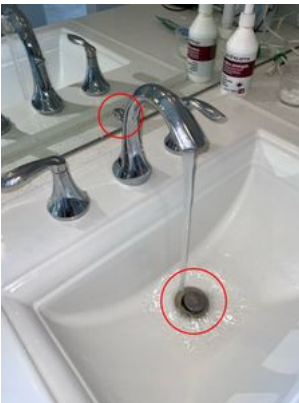
Bathrooms: Bathroom #3: Sink(s)

The right side sink mechanical drain stop does not stay engaged.

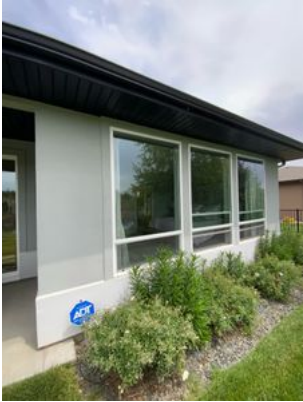
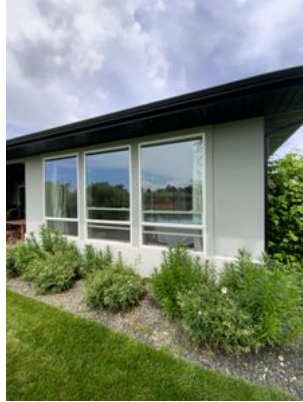
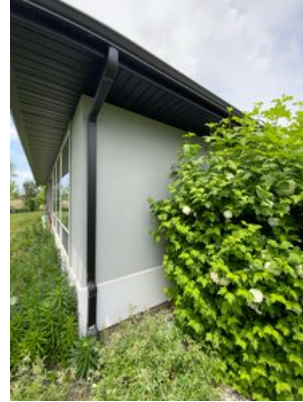
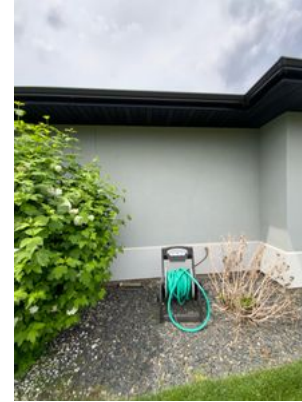
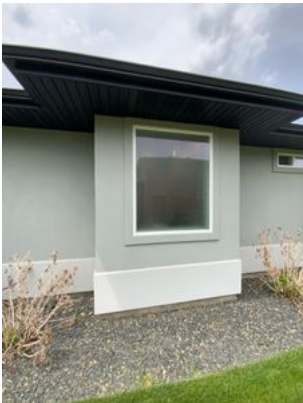
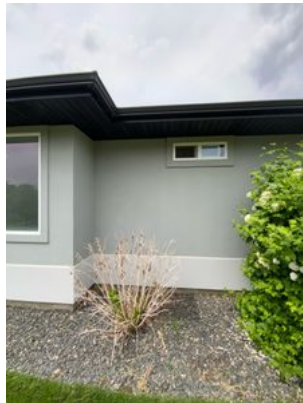
Comment 2
Deficiency

Fractures present at various locations on the stucco exterior. These will periodically need re-sealed and are considered to be routine maintenance with stucco exterior homes.

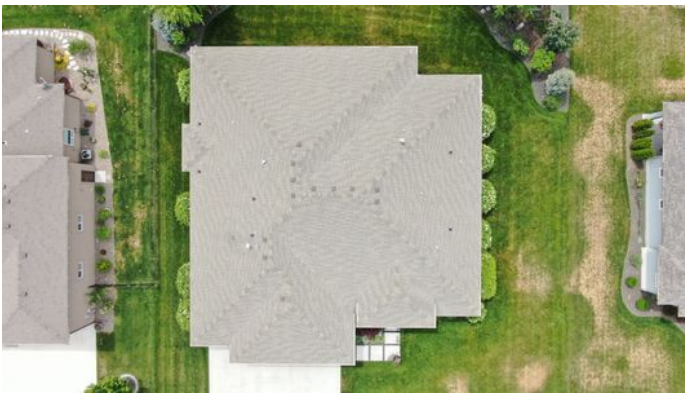
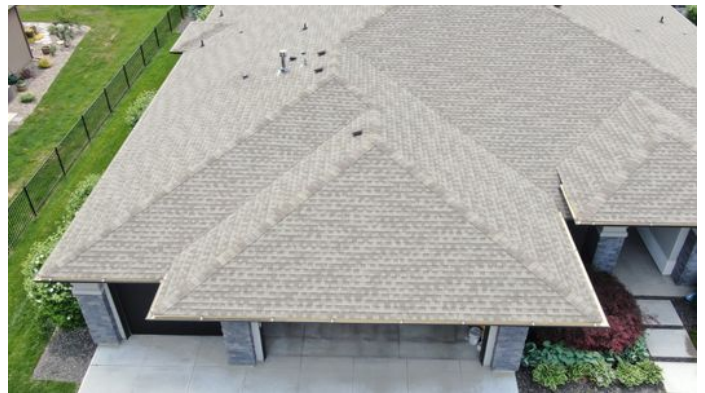
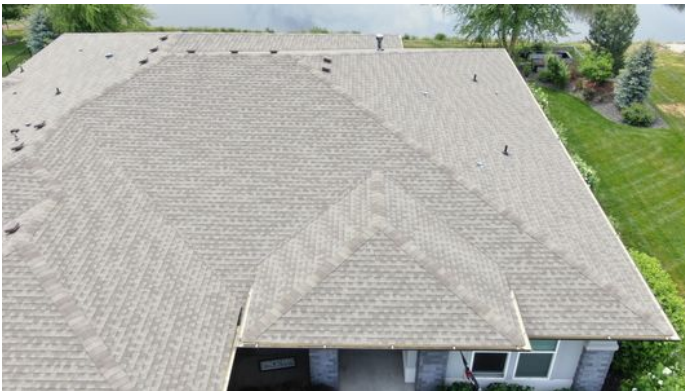
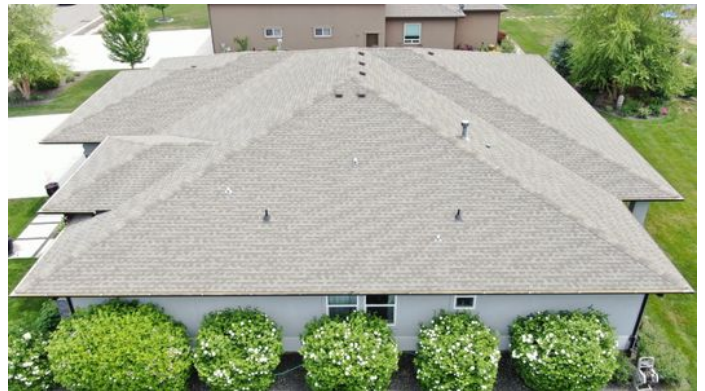
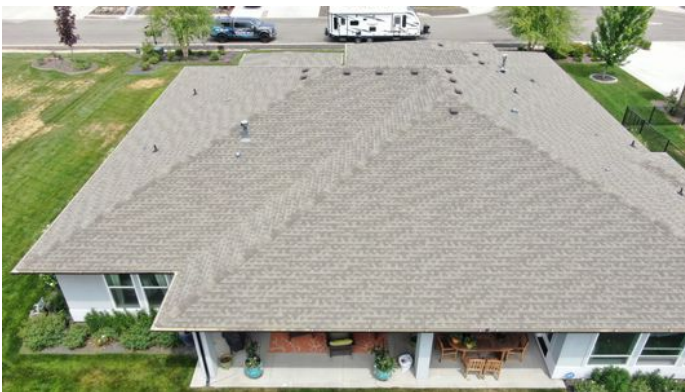
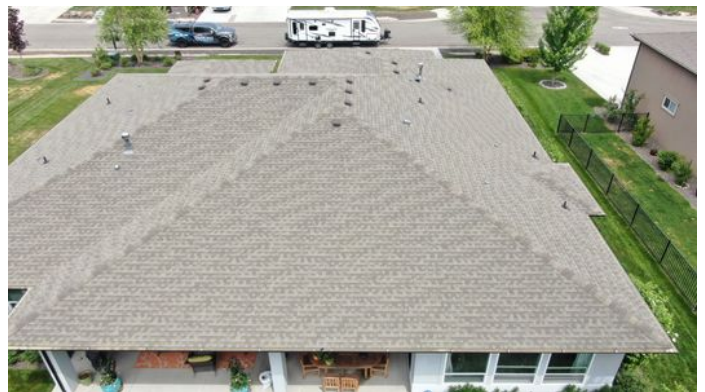
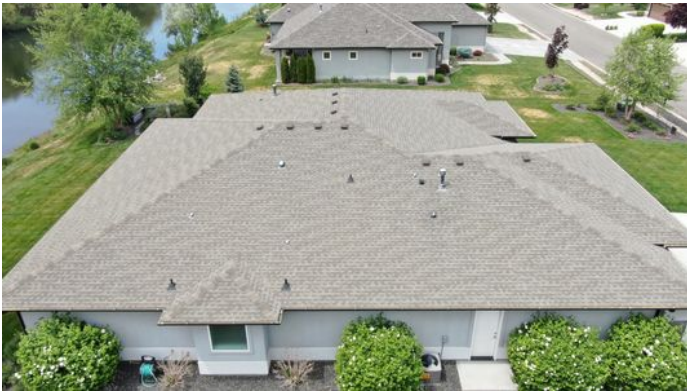
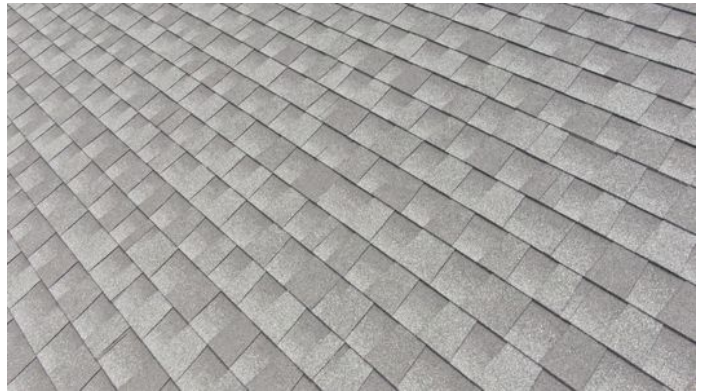
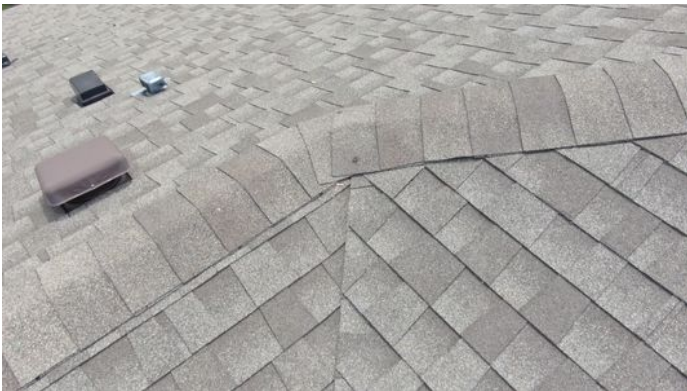
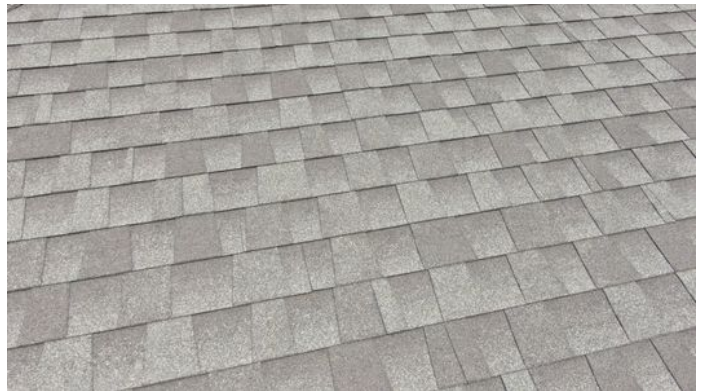
Architectural Shingle

Condition: Satisfactory

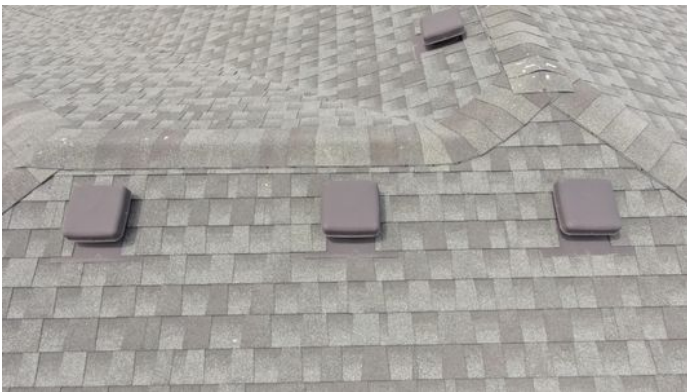
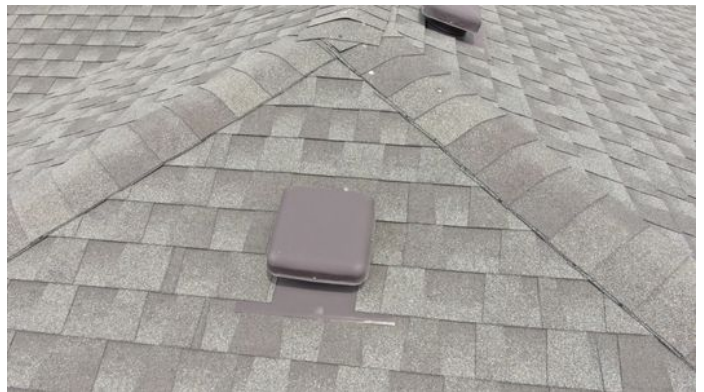
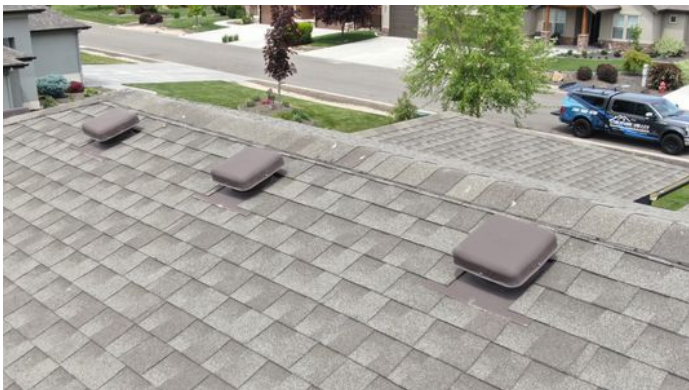
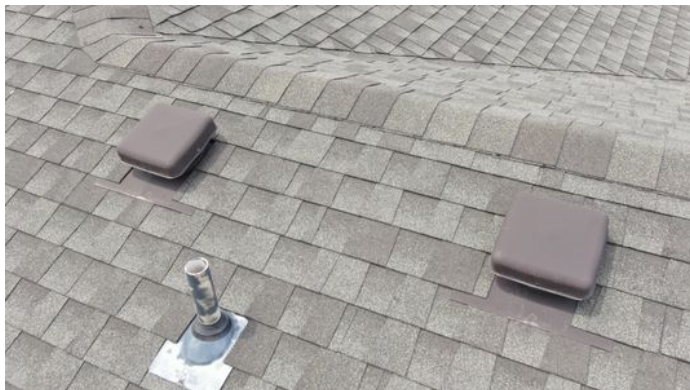
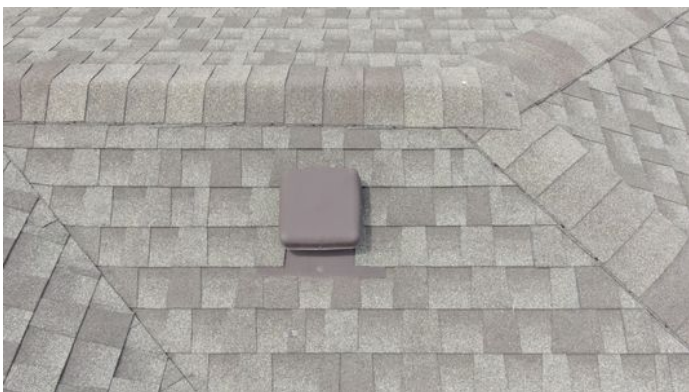
Roof, Soffit

Condition: Satisfactory

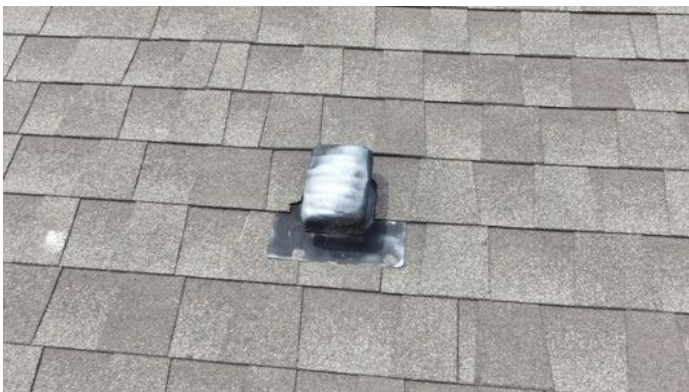
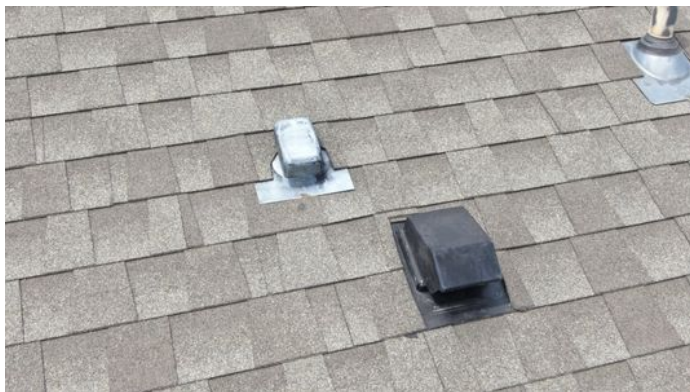
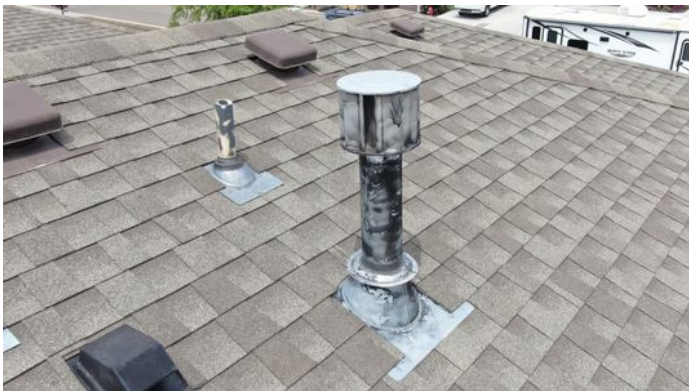
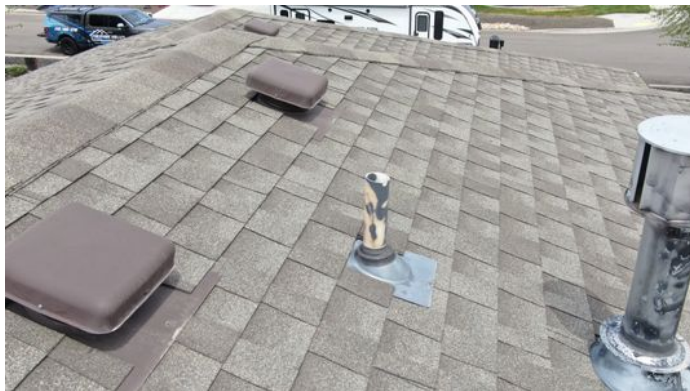
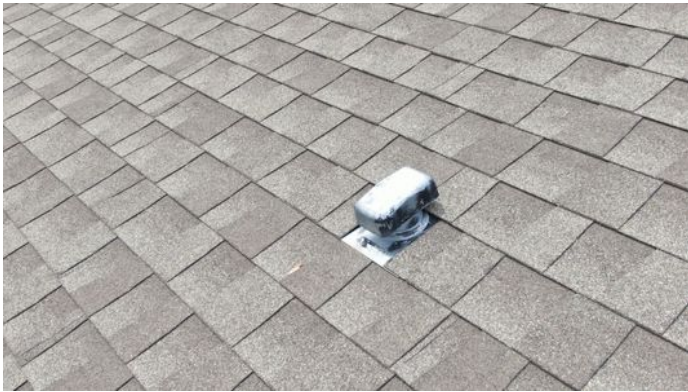
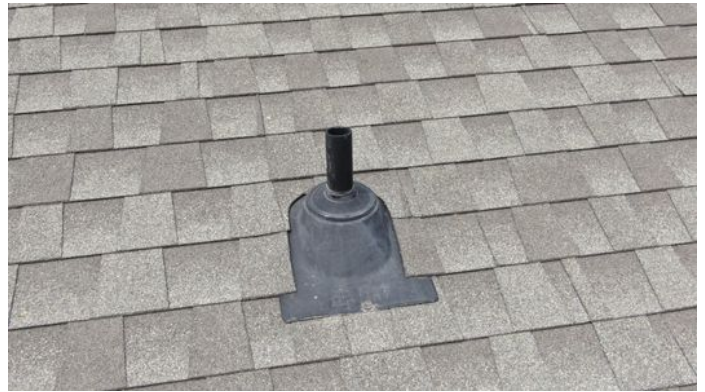
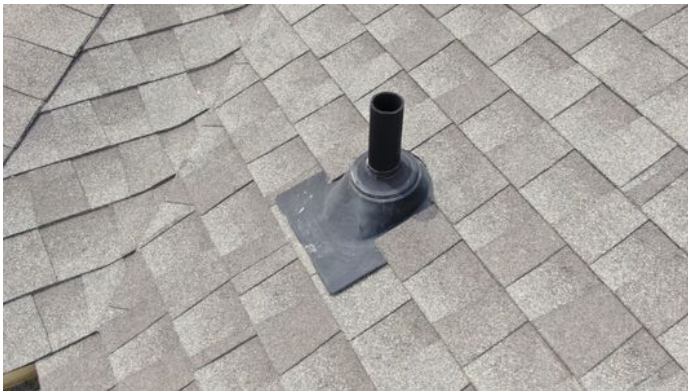
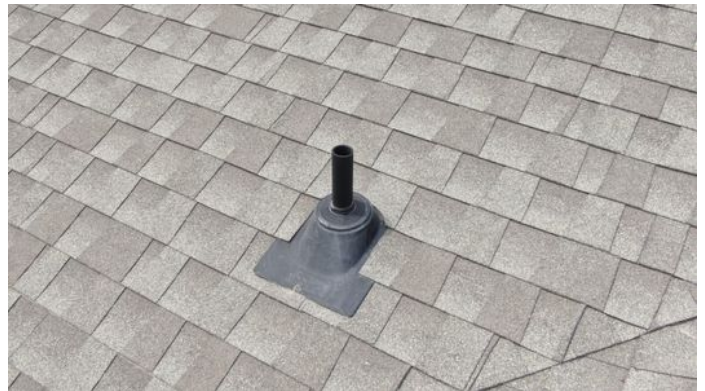
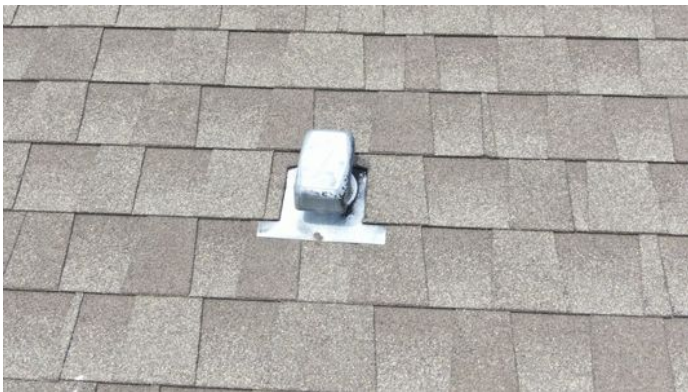
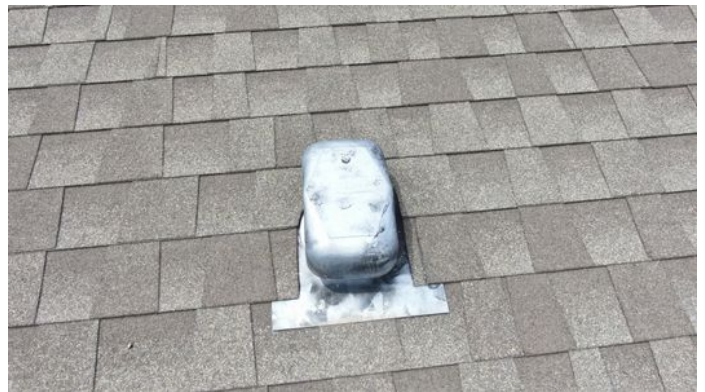
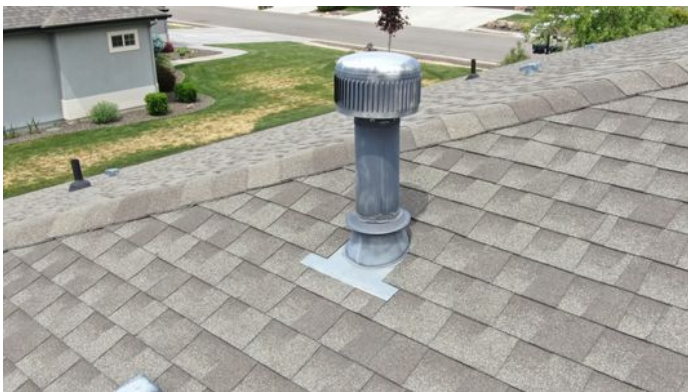
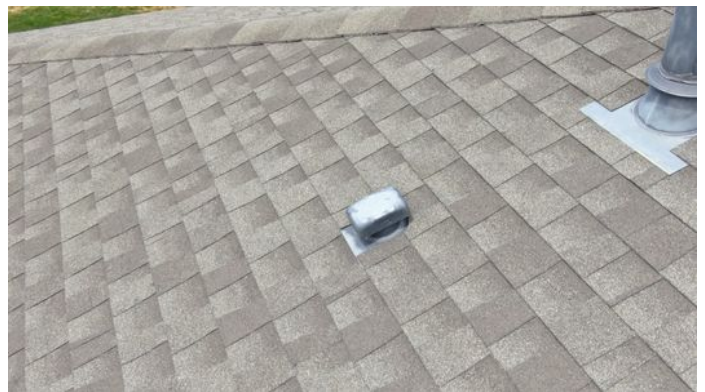
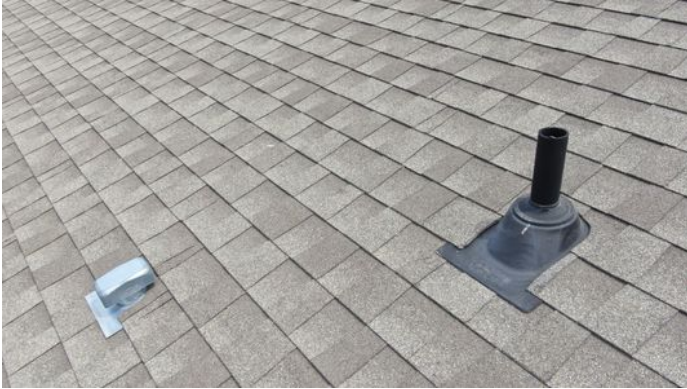
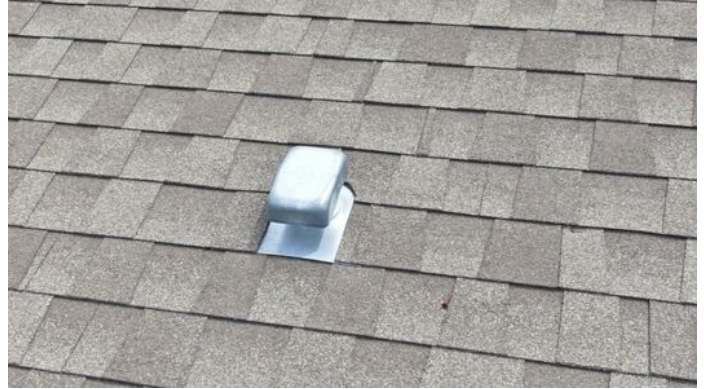
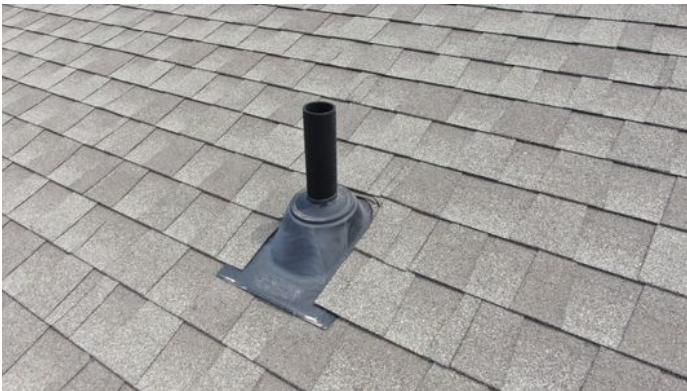
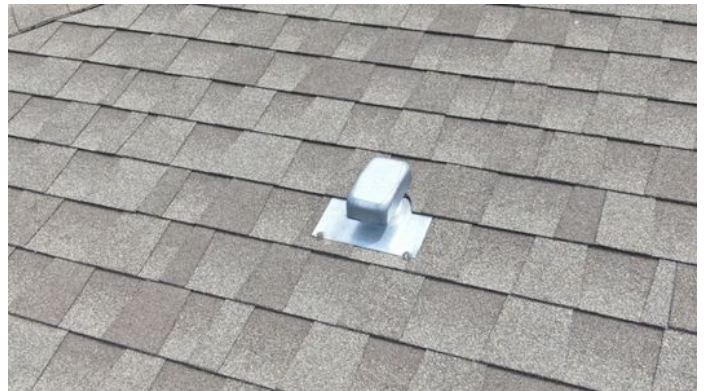
Vent Stacks

Condition: Satisfactory

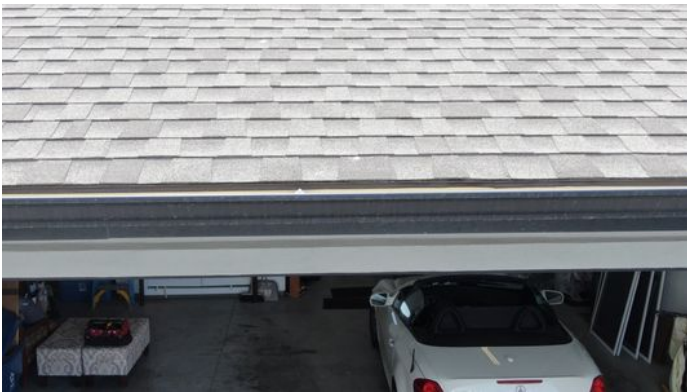
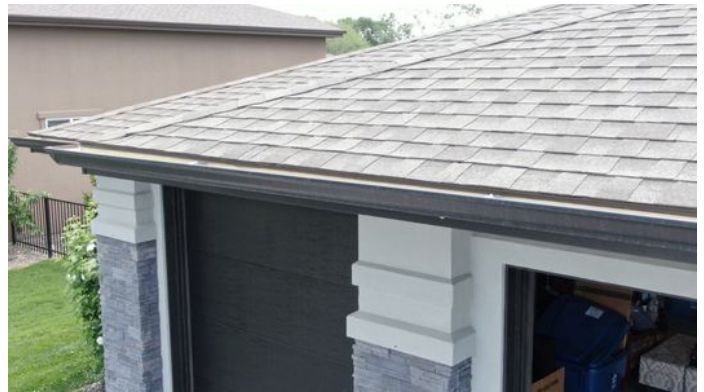
Flashings

Condition: Satisfactory

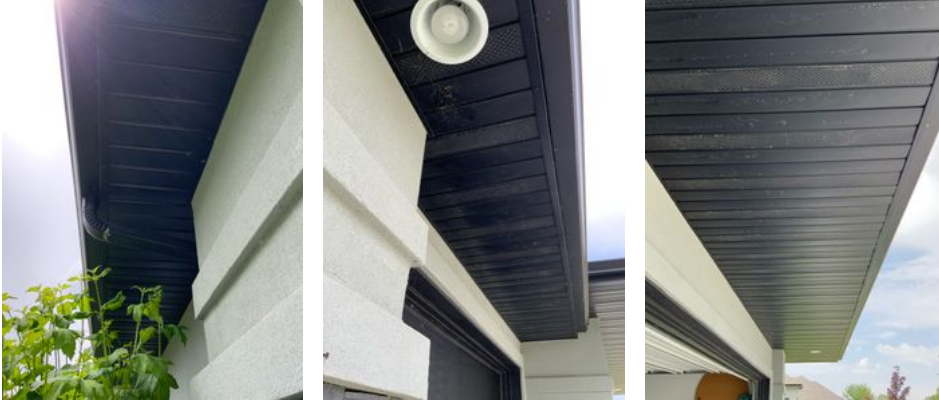
Soffit and Fascia

Condition: Satisfactory

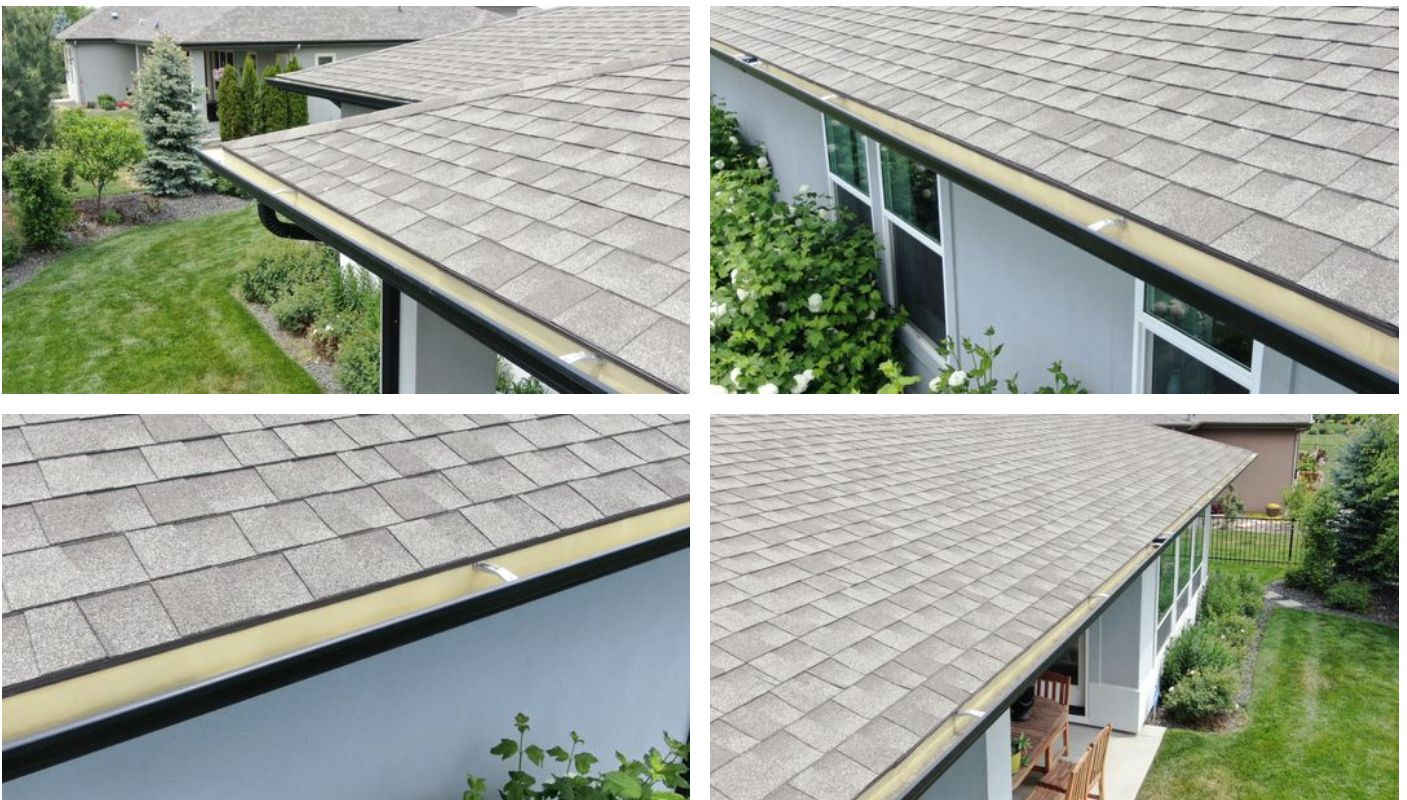
Gutters & Downspouts

Condition: Satisfactory

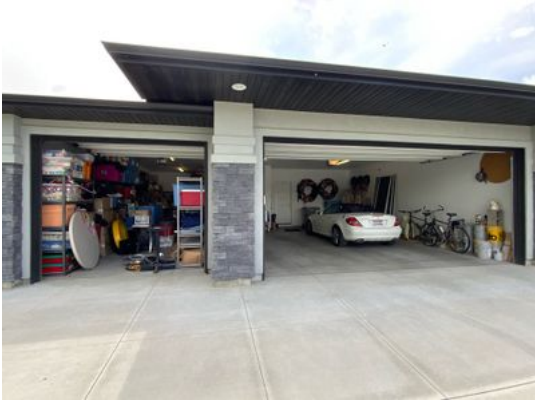
Garage Type

Condition: Satisfactory

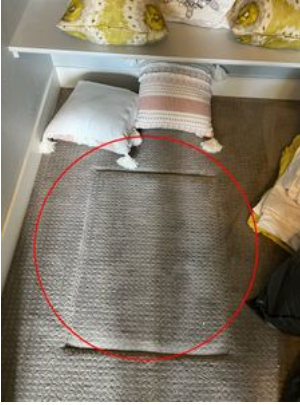
**Comment 6
Information**

Recommend install of a handle at the secondary crawl access.

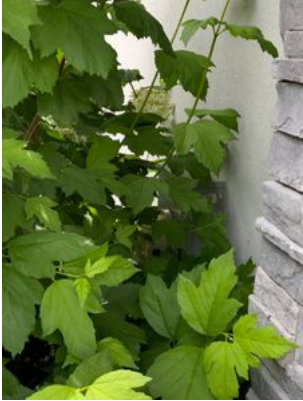
The exterior electrical meter was not fully inspected due to the shrubs.

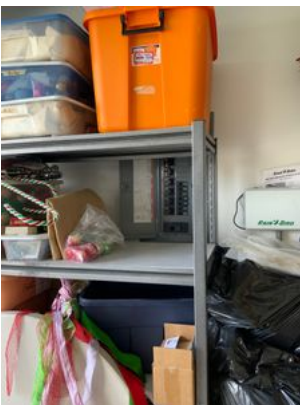
NEC 110-26 states a minimum of 36" in front of panel and 30" width of clearance is required. The inspector cannot remove this electrical panel cover.

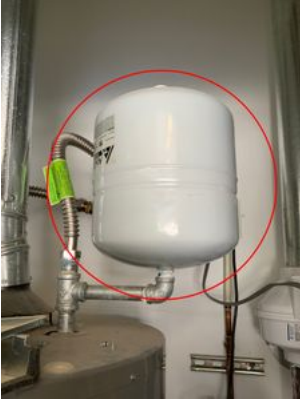
Comment 10
Deficiency

The expansion tank appears to have failed. Recommend further evaluation and repair.

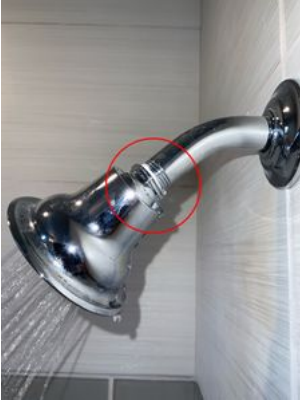
Comment 11

Shower head is leaking where it attaches to the shower arm.

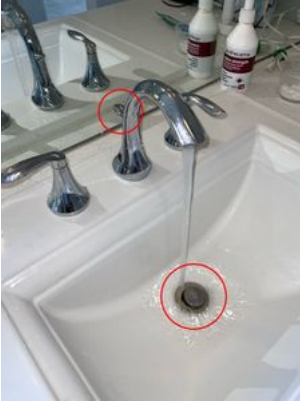
Comment 13

The right side sink mechanical drain stop does not stay engaged.

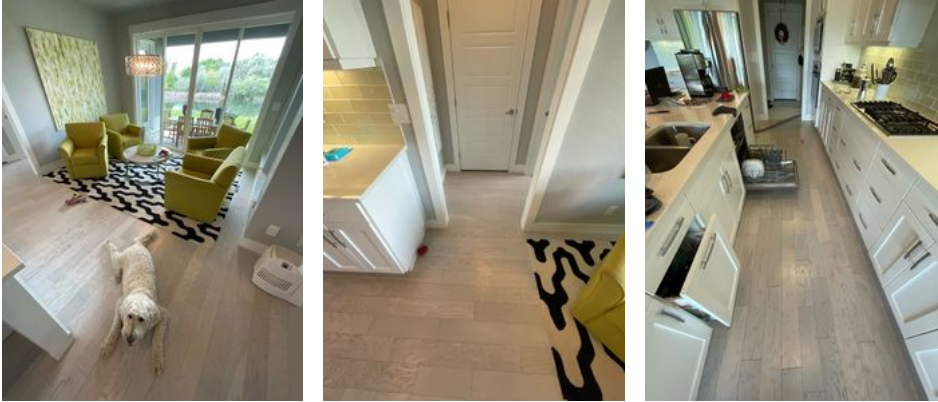
Comment 14
Information

Portions of the floor near the kitchen island were in the process of being repaired.

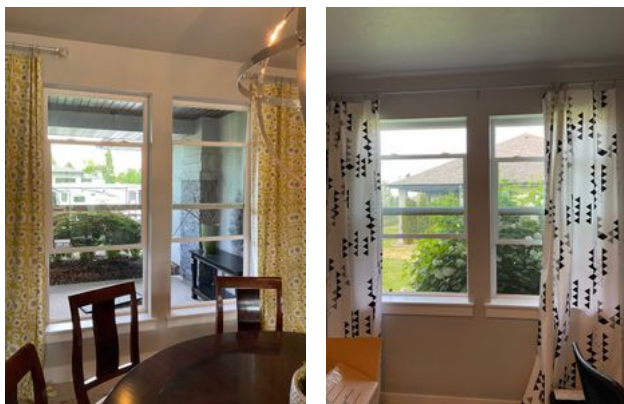
Comment 15

Deficiency

Recommend touch up caulk on interior window sills as needed to improve moisture barrier.
