Treasure Valley Home Inspectors, LLC

## Home Inspection Report

1887 N Buena Vista Ave  
Meridian, ID 83646

Inspected On Mon, Dec 29, 2025 at 9:00 AM

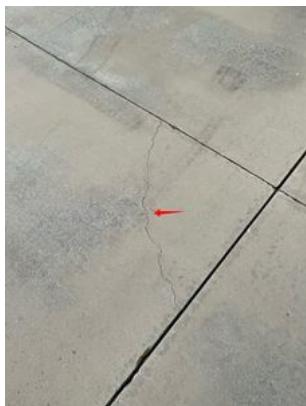
#### Site: Driveway

Fracture present on the driveway slab.

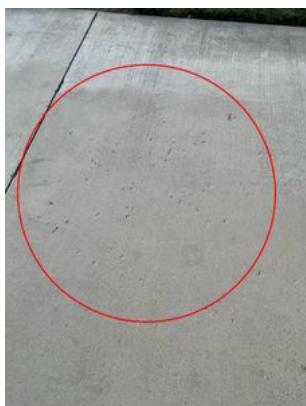
#### Site: Driveway

Spalling of the concrete surface present.

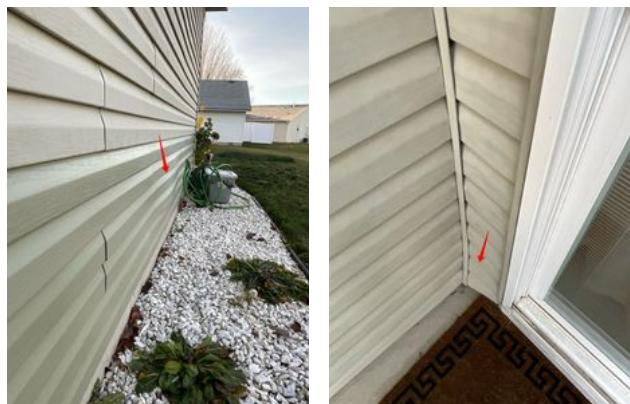
### Exterior: Exterior Covering

Various portions of the siding are bowed/flared.

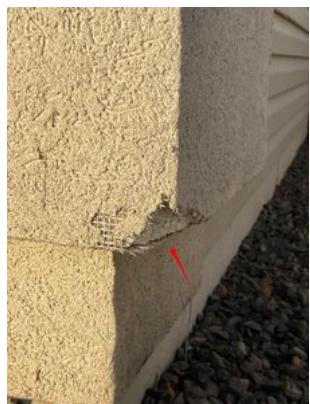
### Exterior: Exterior Covering

A portion of the stucco on the north side corner of the home has chipped.

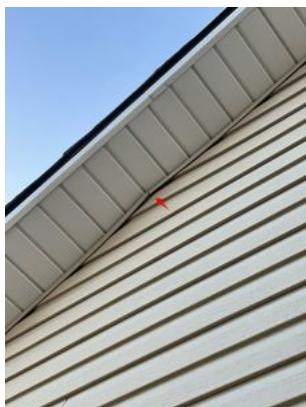
### Exterior: Exterior Covering

A portion of the vinyl flashing trim has split.

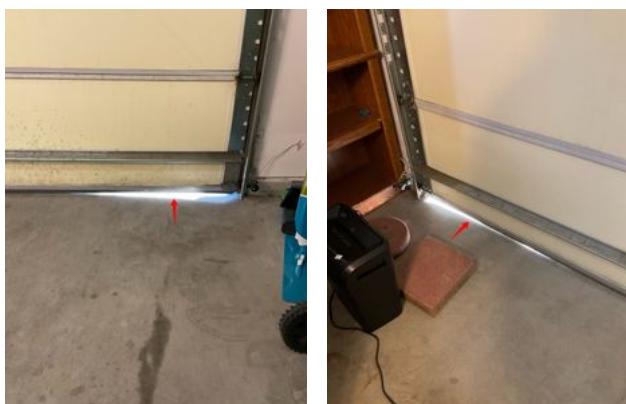
### Garage: Garage Type

The portions of the garage door do not fully seal against the weather stripping.

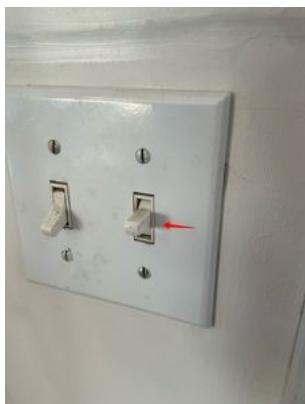
### **Garage**

The garage light switch won't fully switch to the off position.

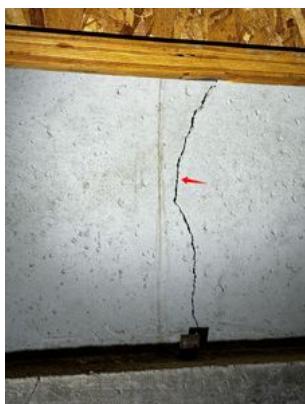
### **Structure: Foundation Material**

Vertical fractures located in foundation concrete. These are not generally indicators of structural settlement. Sealing these fractures may prevent further expansion of the crack due to moisture intrusion/freezing. Recommend monitoring this fracture and sealing if the fracture width expands to 1/8 of an inch.

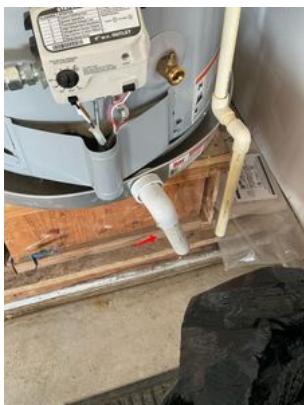
### **Plumbing: Water Heater: Manufacturer**

The drain pan should have a PVC drain line routed to the exterior of the home. This is to prevent water from leaking onto the floor in the event that the water heater begins to leak.

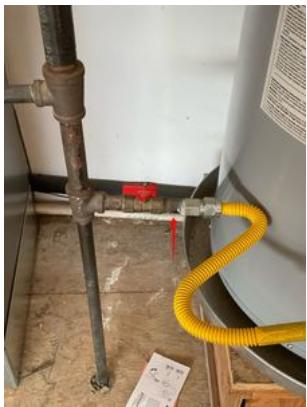
### Plumbing: Water Heater: Manufacturer

No sediment trap was installed on the mechanical equipment gas lines.

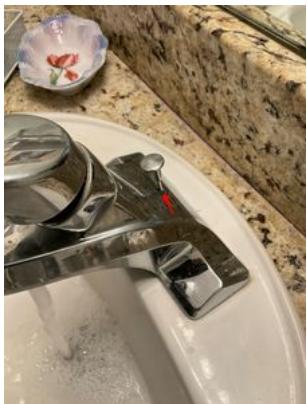
### Bathrooms: Bathroom #2: Sink(s)

The mechanical drain stop is difficult to engage.

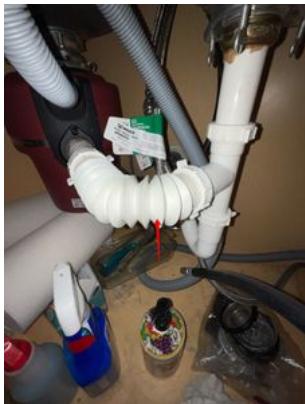
Flex pipe present on the sink P trap. Flex piping is not advised for use in drainage P traps per code P3002.3.1

Recommend repair.

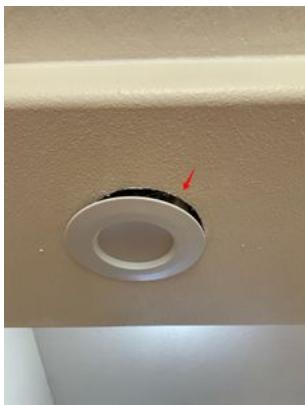
### **Kitchen**

The overhead light above the kitchen sink should be re secured.

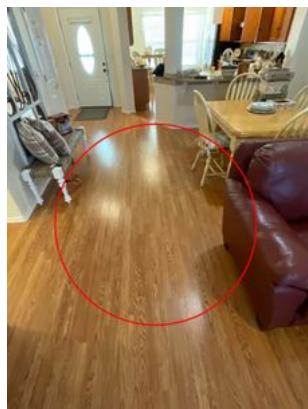
### Interior: Floors

Floor pops/squeaks present.

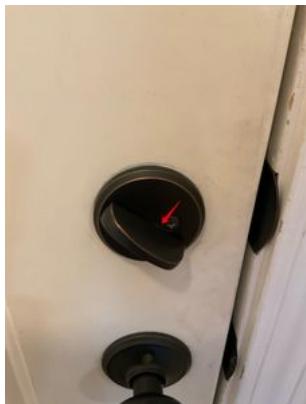
### Interior: Entry Door Types

The front entry deadbolt is sticking. Recommend adjusting.

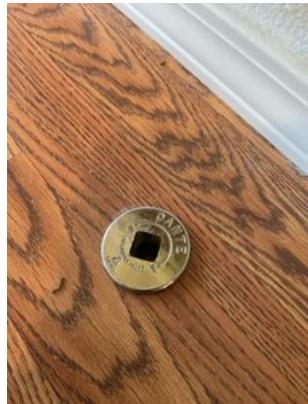
### Interior: Fireplace

The fireplace did not ignite at the time of the inspection. The floor gas valve may be turned off. Recommend further evaluation.

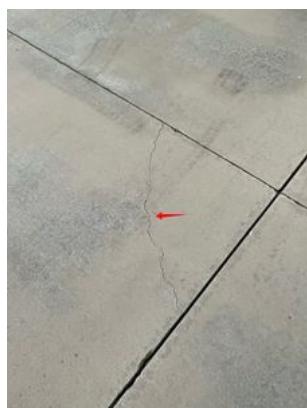
**Comment 2**

Fracture present on the driveway slab.

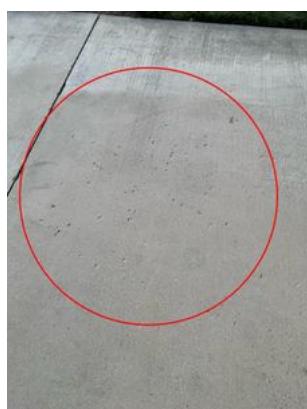
**Comment 3**

Spalling of the concrete surface present.

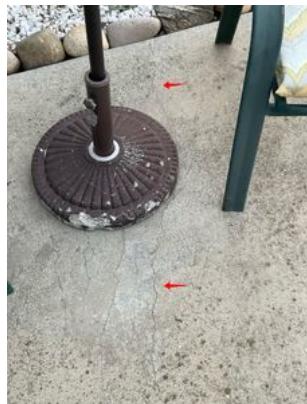
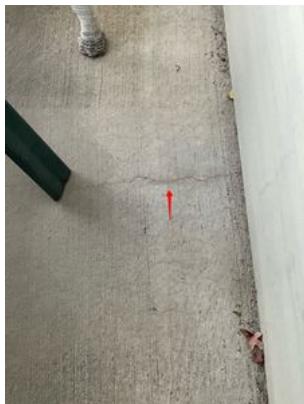
**Comment 4**

Fractures present on the concrete patio slab.

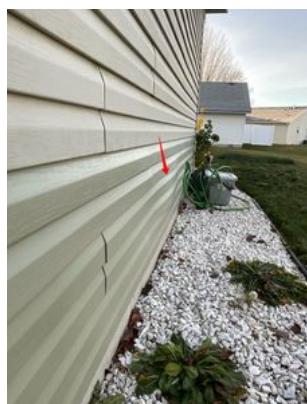
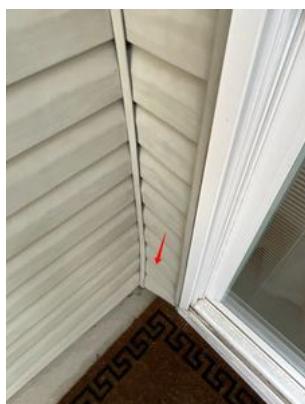
### Comment 5

Various portions of the siding are bowed/flared.

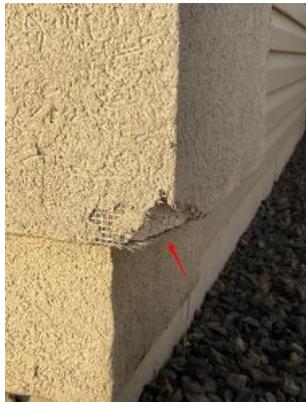
A portion of the stucco on the north side corner of the home has chipped.

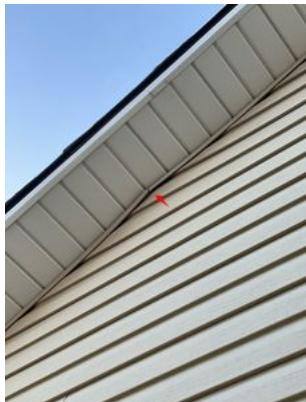
A portion of the vinyl flashing trim has split.

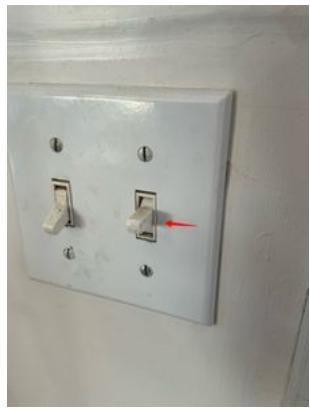
### Comment 11

The garage light switch won't fully switch to the off position.

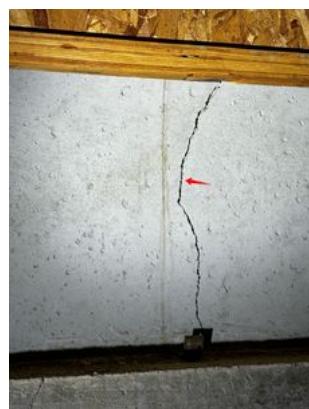
Vertical fractures located in foundation concrete. These are not generally indicators of structural settlement. Sealing these fractures may prevent further expansion of the crack due to moisture intrusion/freezing. Recommend monitoring this fracture and sealing if the fracture width expands to 1/8 of an inch.

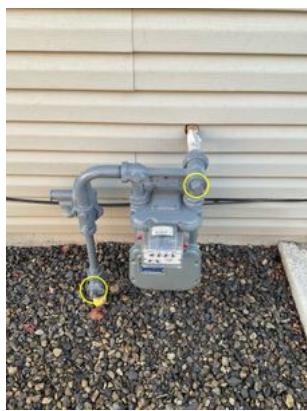
### Comment 18

Recommend sealing the gas line wall penetration to prevent moisture intrusion.

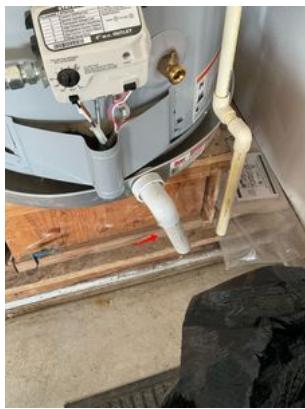
### **Comment 20**

The drain pan should have a PVC drain line routed to the exterior of the home. This is to prevent water from leaking onto the floor in the event that the water heater begins to leak.

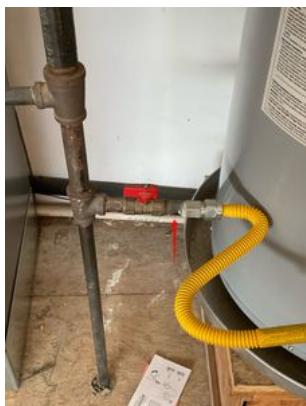
### Comment 21

No sediment trap was installed on the mechanical equipment gas lines.

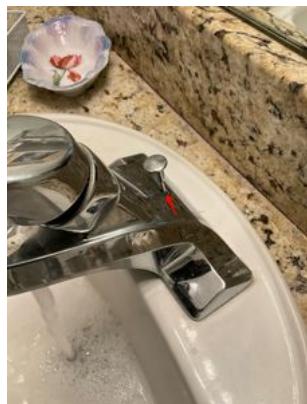
### **Comment 22**

The mechanical drain stop is difficult to engage.

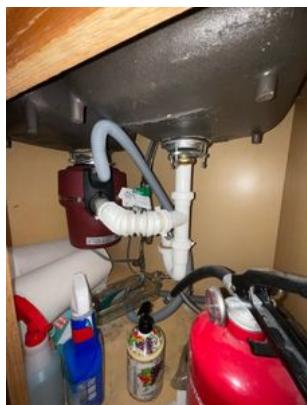
### Comment 26

Flex pipe present on the sink P trap. Flex piping is not advised for use in drainage P traps per code P3002.3.1

Recommend repair.

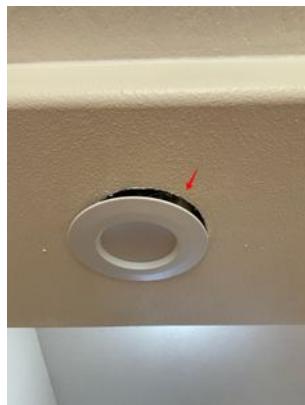
The overhead light above the kitchen sink should be re secured.

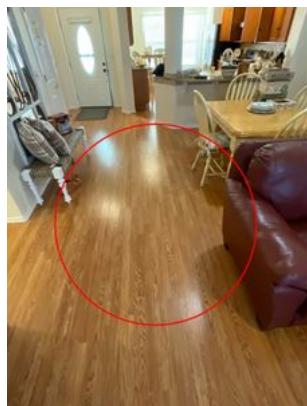
### Comment 28

Floor pops/squeaks present.

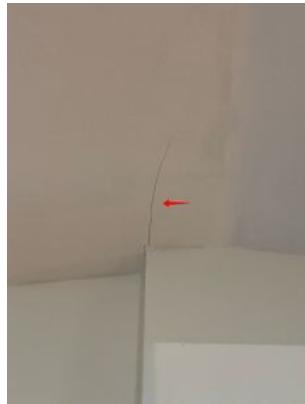
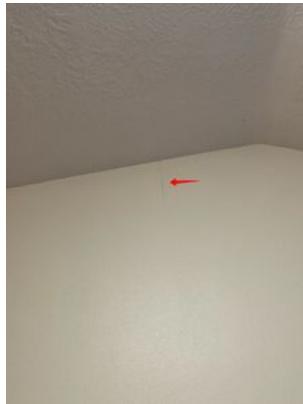
### Comment 29

Fractures present in the ceiling drywall. Portions of this fracture are at a tape joint while portions of the fracture indicates that a portion of the sheet of drywall has broken . This could be from someone walking in the attic or is a sign of past

structural settlement. No further signs of structural settlement were noted at the time of the inspection i.e. window/door header fractures, floor slopes, significant foundational fractures etc. The ceiling drywall should be repaired and monitored. If the fracture happens again then active settlement may be occurring. Recommend further evaluation and repair.

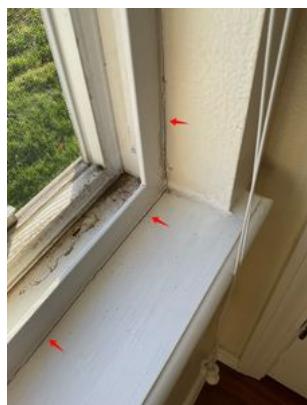
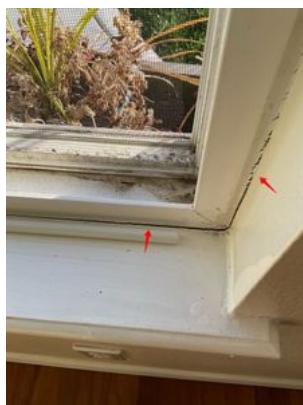
### Comment 30

Recommend touch up caulk on various interior window sills as needed to improve moisture barrier.

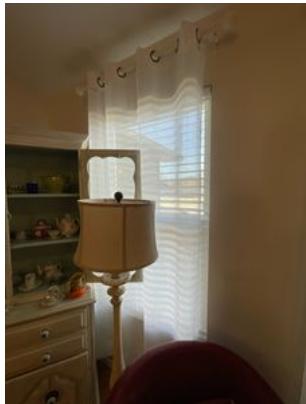
**Comment 31**  
**Information**

This window was not inspected due to owners belongings.

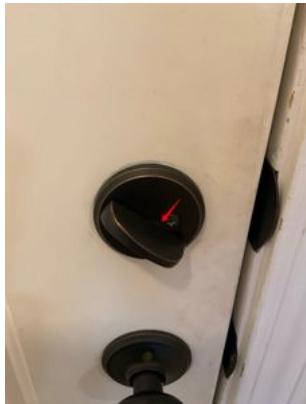
The front entry deadbolt is sticking. Recommend adjusting.

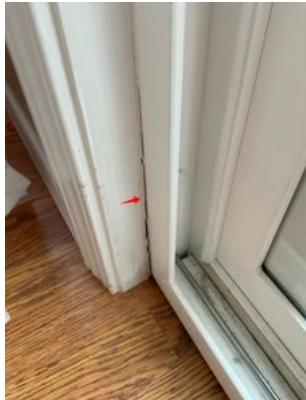
**Comment 33**

Recommend touch-up caulking around the rear entry door frame as needed to improve the moisture barrier.

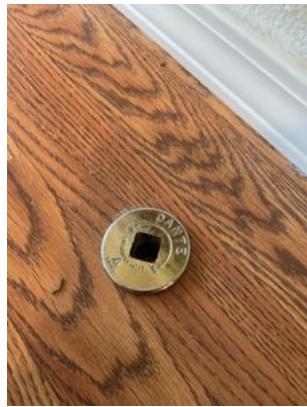
Condition: Further Evaluation Required

The fireplace did not ignite at the time of the inspection. The floor gas valve may be turned off. Recommend further evaluation.
